# Durability characteristics of straw bales in building envelopes

Andrew Thomson <sup>a</sup> and Pete Walker <sup>b</sup>

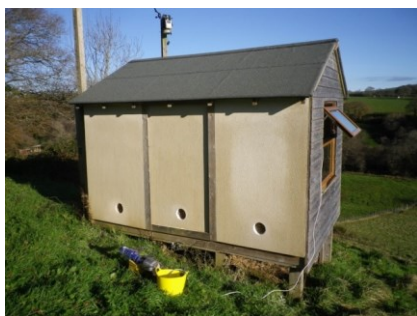
Figure 5: Monthly average relative humidity data plotted against temperature for Panel A

Figure 5 presents mean monthly average data for relative humidity and temperature recorded from the base sensors within panel A. These data corresponds with the location of the inspection survey reported below. These data are presented against the Fraunhofer Institute isopleth boundaries for mould growth. It is evident that the straw at the base of panel A spent several prolonged periods in conditions that Sedlbauer et al [8] suggests would support significant mould growth. Whilst these monitoring results suggest that the straw may have been subject to degradation, it is important to understand the severity of this exposure and whether it posed a long term risk to the integrity of the straw. To do this the panel was opened-up to allow direct visual inspection of straw conditions. A 150 mm core of lime render was removed from the base of the exterior face of the panels using a core drill (Figure 6). The straw behind the render was inspected and photographed before a specimen of straw was taken for gravimetric assessment of straw moisture content in accordance with BS EN 12570 [13]. Figures 7 and 8 show the core removed from panel A and the straw behind the render.

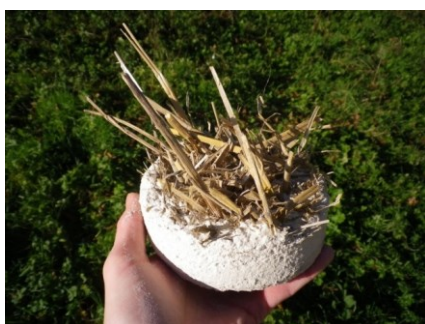
Figure 6

Figure 6: Opening up at base of panels

Evidence of significant decomposition was not apparent in any of the five panels opened up. However, a level of discolouration of the straw had occurred to a varying extent in all five panels. Whilst no fresh mould growth was evident the straw at the extreme outer face felt marginally damp to touch and had a perceptible musty odour.

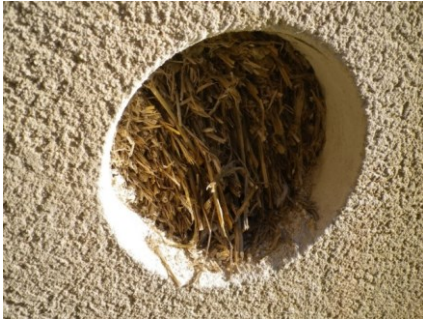
Figure 7

Figure 7: Render core removed from base of panel A.

A primary objective of the intrusive inspections was to confirm the straw moisture content through gravimetric means. Therefore, after removing the render core, a specimen from the outermost exposed straw was collected to determine its moisture content by oven dry method. To prevent further moisture loss the straw was placed in an airtight container prior to oven drying at 105°C until constant mass achieved, usually within 24 hours. For panel A the gravimetric moisture content of the straw immediately behind the render was measured at 28.4%.

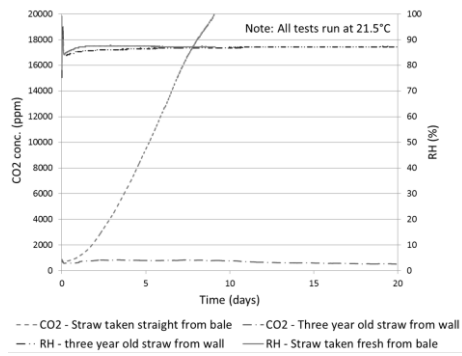
Figure 9

Figure 9: Test setup for durability testing

In this study straw specimens were placed in sealed HDPE containers to allow CO<sub>2</sub> concentrations to be monitored. Saturated salt solutions within the sealed containers were used to control relative humidity within the containers and micro fans were run throughout testing to ensure the air within the container did not become stratified (Figure 9). Use of saturated salt solutions was in accordance with BS EN ISO 12571:2000. Temperature was controlled throughout the experiment by placing the

containers within an environmental chamber. Relative humidity, temperature and CO<sub>2</sub> were monitored within the container using a single GE sensor unit mounted to the underside of the lid.

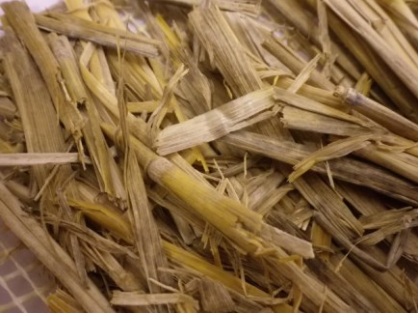
Figure 10

Figure 10: Comparative microbial activity as indicated by CO<sub>2</sub> evolution

The first experimental test compared the behaviour of fresh straw with straw taken from the external face of a rendered straw bale wall. This straw had been within the wall for three years and appeared discoloured though not significantly degraded. The two specimens were placed in sealed environments at 87% relative humidity and held at a constant temperature of 21.5°C. Carbon dioxide levels within the sealed containers were then monitored as a means of detecting microbial growth. Prior to testing, the specimens were both stored at 20°C and 70% RH for seven days in order to ensure they both had an equal moisture content at the start of the test. The same mass of straw was then tested for both samples. The results of the testing are shown below in Figure 10.

It is evident that the three year old straw did not support any significant new microbial growth. However, a rapid increase in CO<sub>2</sub> concentrations was observed for the fresh straw, indicating rapid microbial growth. This is further supported by visual inspection of the specimens after testing, as shown in Figure 11 and Figure 12. Here mould growth can be clearly seen on the surface of the fresh straw whilst no visible mould growth occurred on the straw removed from the three year old wall.

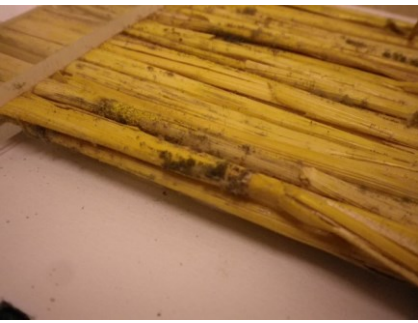
Figure 11

Figure 11: Three year old straw following exposure to 87% RH at 21.5°C
