Warren, LA, Briggs, KM & McCombie, PF 2016, 'Thermal imaging assessment of drystone retaining walls: some case studies', *Proceedings of the ICE - Forensic Engineering*, vol. 169, no. 3, pp. 111-120.  
<https://doi.org/10.1680/jfoen.16.00012>

# Thermal imaging assessment of drystone retaining walls

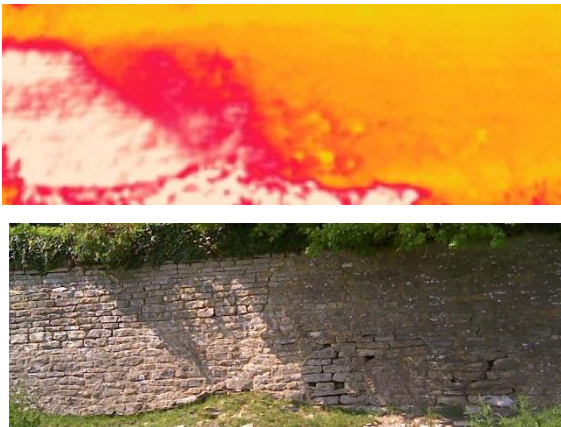
The influence of shading can affect the thermal images, as shown in Figure 6. Part of the wall is shaded by a large tree, and where this shading occurred very little thermal information could be gathered in comparison to the unshaded adjacent areas. This effect was still present once direct sunlight was no longer present on the wall.

**Figure 6:** Thermal image showing the effect of shading.
