Yin, X, Lawrence, R, Maskell, D & Sun, C 2019, 'Assessment of straw degradation inside straw bale walls in severe cold region of China', Paper presented at 3rd International Conference on Bio-Based Building Materials, Belfast, 26/06/19 - 28/06/19.

## ASSESSMENT OF STRAW DEGRADATION INSIDE STRAW BALE WALLS IN SEVERE COLD REGION OF CHINA

Yin.Xunzhi<sup>1,2</sup>, Lawrence.Mike<sup>3</sup>, Daniel.Maskell<sup>4</sup>, Sun.Cheng<sup>1,2\*</sup>

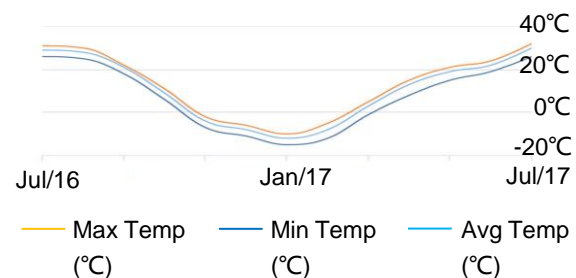
Figure 2. Average monthly maximum temperature, minimum temperature and average temperature in Changchun from July 2016 to June 2017. (Online, 2017)

The experimental straw bale building was constructed in Changchun, in the Jilin province of northeast China (Figure 2). Changchun is subject to a typical temperate monsoon climate. In the national thermal design code of civil buildings (Development, 1994), the area is identified in the severe cold climate zone which is part of the temperate monsoon climate zone. Temperature peaks at around 30°C in the area from June to August and drops to below freezing after late October annually (Figure 2). The highest monthly air humidity level is 88% and it appears in January (Figure 3). The monthly humidity levels are from 63% to 72% in summer during which the highest temperature appears.

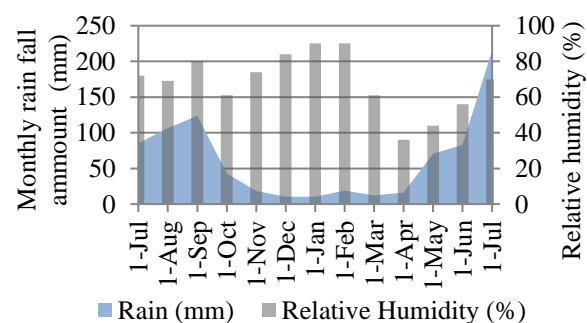
Figure 3. Average monthly Humidity and rain fall in Changchun from July 2016 to June 2017 (Online, 2017).

The climatic features of Changchun represent three typical climatic characteristics in northern China: Firstly, both the air temperature and humidity are at high levels in summer months. The daily high temperatures are around 30°C in summer months. Due to the features of temperate monsoon climate, rainfalls are expected

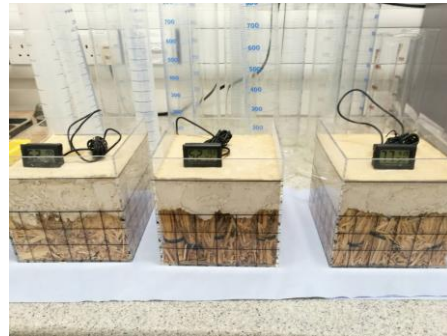
Figure 4. Section of walling construction in the degradation potential experiment

Straw bales and lime render were constructed in three transparent boxes to represent walling constructions of straw bale buildings (Figure 4). Both rice straw and wheat straw were used in different wall constructions. The straw was baled in small bundles and placed both parallel and perpendicular to the lime render to represent the laid flat stacking method and the laid on-edge stacking method in typical construction of straw bale buildings. A RH/T sensor was installed in the straw bundles in each specimen (Figure 5). The thickness of lime render was 50mm in the construction of specimen. The adjacent area between the lime render and the transparent boxes were sealed by wax to avoid direct pass of environmental RH to travel into the straw in the specimen. The transparent boxes of the walling constructions were labelled into small rectangle to identify possible area of straw degradation in the research.

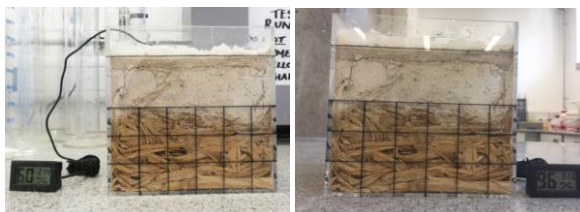
Figure 7. Specimen of rice straw with parallel placing before the degradation research (left) and after 12 weeks in climatic chamber (right)

The visual checks of the specimens does not identify any recognisable straw degradation both in the experimental process and at the end of the experiments. Comparisons of the specimens of the straw status before experiment and after experiment are shown in Figure 7, Figure 8 and Figure 9. Existing research on sorption isotherm of straw have identified that straw would have serious degradation after more than 4 weeks exposure in the environment of 95% RH and 22°C (Carfrae, 2011, Lawrence et al., 2009). The straw in typical lime rendered construction becomes protected.

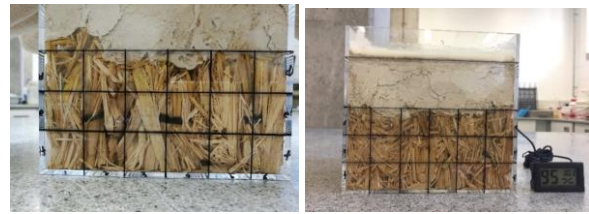
Figure 8. Specimen of rice straw with perpendicular placing before the degradation research (left) and after 12 weeks in climatic chamber (right)

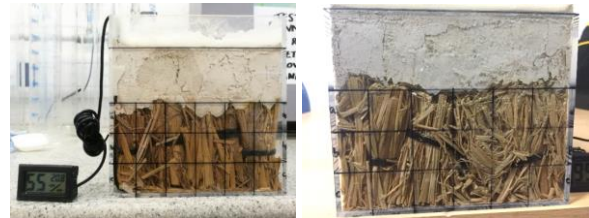
Figure 9. Specimen of wheat straw with perpendicular placing before the degradation research (left) and after 12 weeks in climatic chamber (right)

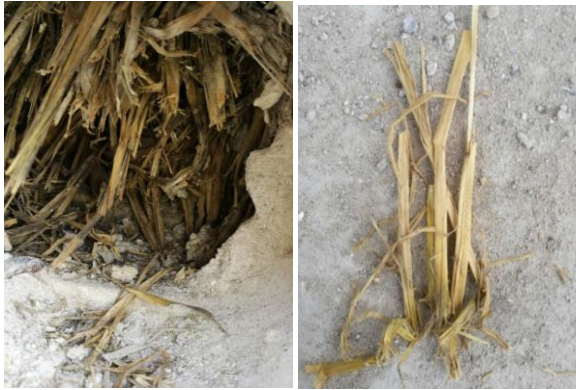
Figure 10. Opening of external render (left) and straw adjacent rendering layer (right) of low position of laid flat bale wall

To examine the straw conditions behind rendering layer, rendering layer of 8 positions (Table 1) were removed to expose the straw inside the bale walls in the second onsite visit after 11 months monitoring research on 19<sup>th</sup> June 2017. The straw was visually checked onsite. There was limited degradation of straw at the interface between straw bales and external rendering for all opened positions (Figure 10). The degradation appears on the interface of lime render and straw bales and penetrated 2-3 cm deep into the straw bales. The straw behind the interface remains golden colour inside the walls. The site visit confirms that the straw was in good condition inside the straw bale walls for one year. Unlike

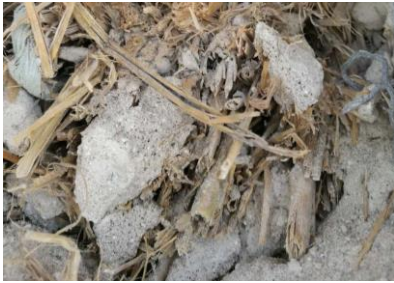
Figure 11. Mixture of straw and lime stucco outside the high position of laid flat bale wall

the limited straw degradation on the interface between straw bales and the lime render layers, the straw was in good condition with mixture of lime render (Figure 11).

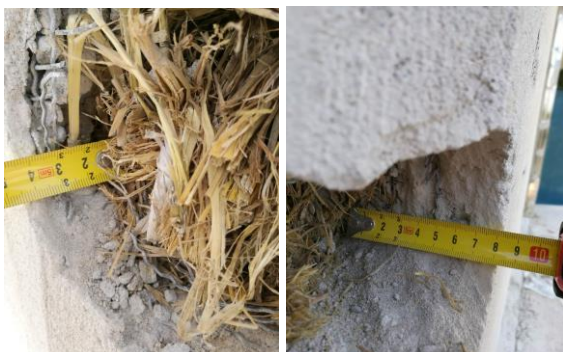
Figure 12. Straw conditions behind opening locations with thin rendering thickness (left) and thick rendering thickness (right)

The thickness of lime rendering varies significantly from the design thickness (Figure 12). The thickness variations of lime rendering was between 40mm to 105mm in the experimental building (Table1). The thicker lime rendering layers may provide more moisture buffering to straw bales and introduce more initial moisture in the straw bales at the drying stage of lime rendering. The bales behind the thicker lime rendering would have higher initial moisture content and have longer drying period than the one behind thinner lime rendering. However, the thicker lime render layers do not have significant effect on straw degradation from visually inspection.

During the onsite visit, the straw outside the high position of on-edge bale wall show insignificant decolourisation and no notable mould growth are identified on the straw surface by visual inspection through the drilled opening outside the monitoring location (Figure 12). Even though straw degradation is identified behind the render layer outside the low position of laid flat bale wall, the situations are not as severe as the prediction of the isopleth model. The limited straw degradation only appears on the surface of straw bale stacking and the straw remain unchanged inside the bales.
