Service and maintenance damage assessment of composite structures using various modes of infrared thermography

Abstract. Carbon Fibre Reinforced Polymers (CFRPs) have been widely used recently in aerospace technology as primary materials. During aircraft operation the combination of thermo-mechanical loads, gradually degrades the material properties. Therefore, the development of reliable and cost effective damage inspection protocols throughout the service life of these structures is of primary importance for their safe function. Within the scope of this study, Infrared Thermography (IrT) was employed with the aim of assessing the structural integrity of composite aero-structures in both maintenance (off-line) and service (on-line) conditions. In the maintenance concept, IrT was employed in Lock-in mode to evaluate artificially induced damage in bonded repaired materials. For this purpose, various configurations of damage were investigated. In the service concept, IrT was employed for the continuous monitoring of loaded repaired structures in order to assess in real-time any progressive evolution of de-bonding which could lead to failure of the bonded patch repair. The experiment

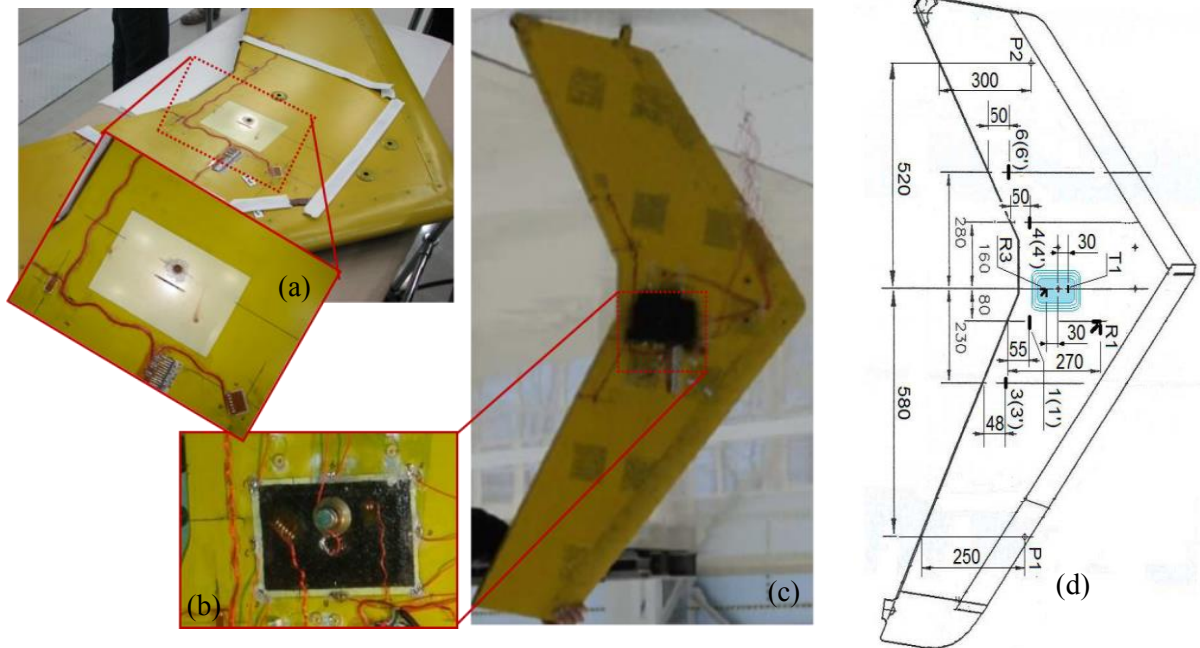
Figure 1. (a) Artificial crack (35mm), patched region, (b) applied bonded patch ($80 \times 120 \text{mm}^2$), (c) SW 4 helicopter vertical stabilizer, (d) schematic representation of the stabilizer.

The structure of the stabilizer consisted of an internal core HexWeb CR III-3,8 5/32-10 (5052). The honeycomb thickness diverges from 32mm to 34.2mm. The aluminum skin was manufactured by the 2024 T3 alloy sheet. The thickness of the external surface varied from 0.4mm to 1.5mm. Figure 1 depicts the prepared for test stabilizer as well as a scheme with the dimensions of the wing structure.

In Figure 1b and 1c one can distinguish the applied bonded composite patch. The artificial crack is shown in Figure 1a. As can be seen, the crack was created close to the bolted joint. Figure 1d displays a schematic representation of the wing. For the requirements of the composite patch, the Hexcel 43280s series carbon fabric was adopted. As for the matrix, the Epocast 52 A/B was utilized.

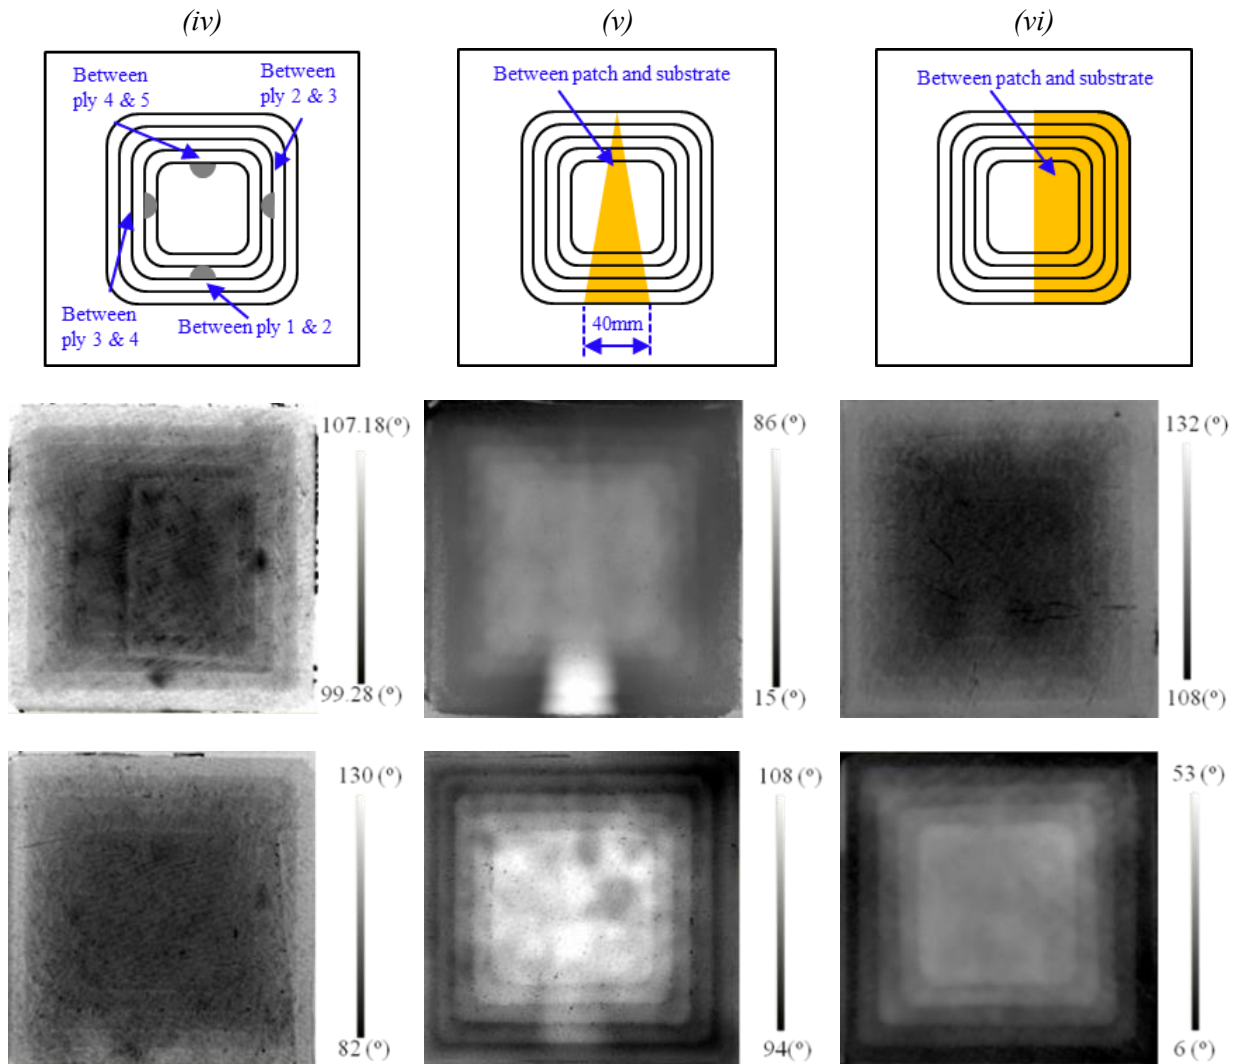
Figure 2b. (A) Coupon configuration, (B) Phase images by lock-in thermography; Al substrate, (C) Phase images by lock-in thermography; Composite substrate, (iv) Delamination between patch layers, (v) Triangle de-bonding, (vi) 50% bad adhesion.

Figures 2a (i-iii) and 2b (iv-vi) depict the thermographic images derived when scanning the repaired plates with LT. Grey and yellow coloured shapes on the coupon configuration schematics represent the location and shape of the artificially induced damages. The thermographic experimental parameters are listed in Table 1.

As is obvious from Figures 2a and 2b, all interrogated artificial defects were detected. In Figure 2a (i) the undamaged reference specimen is depicted. Figure 2a (ii) shows the inserted teflon defect in the centre of the repaired plate. In the case of Al substrate, damage is easier witnessed when using the colorful palette. In Figure 2a (iii) all artificial PTFE flakes between the patch and the mother structure are visible. In Figure 2b (iv) the induced damage between the layers of the patch can be readily discerned. A surface defect visible to naked eye is also identified. In Figure 2b (v) the triangular Teflon insert is easily unscrambled. Figure 2b (vi) depicts the 50% simulated bad adhesion. In this damage configuration thermography was not as successful as for the rest. For this damage concept, oil grease was employed to provoke “bad” adhesion. The thermographs indicate that “bad” adhesion was not traceable. On the contrary it is possible that the majority of the patch/substrate interface remained intact. Poor adhesion is manifested as fade bright areas in the middle of both repaired substrates. In all phase images above the different layers of the patch are visible. Moreover, high consolidation

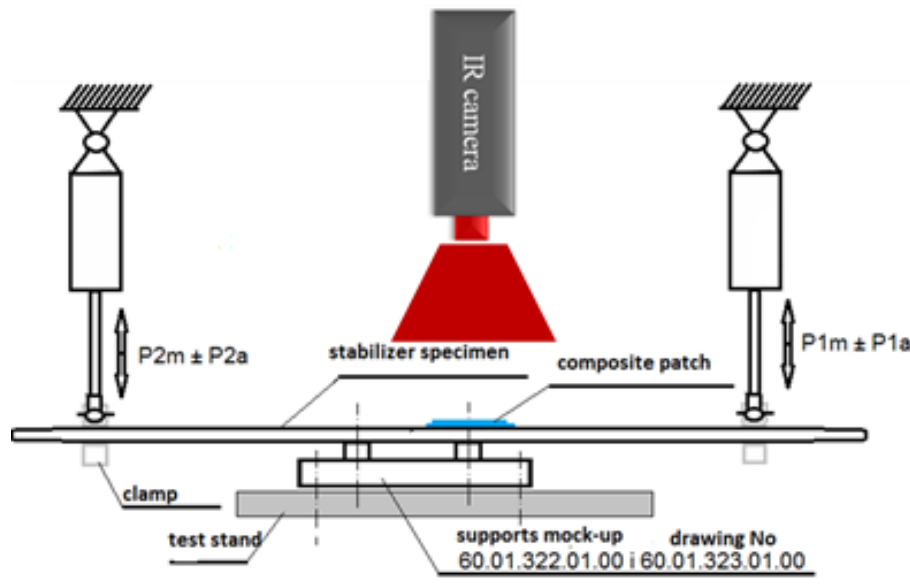
Figure 3. Experimental setup.

In Figure 3 the testing configuration is depicted. The induced bending moments were in different amplitude in order to equilibrate the distance difference between the centre and the clamped points. The structure was tested in 20Hz cyclic bending fatigue. The infrared camera was synchronized with the frequency of the testing machine providing both amplitude and phase images. The infrared sensor was appropriately positioned vertically-faced above the repaired side of the stabilizer (Figure 3). The distance between the camera and the stabilizer was approximately 0.8m. Having two signal outputs from the controller, the camera was connected with the P1 loading moment. The frame rate of the infrared camera was set to capture four images per loading cycle.

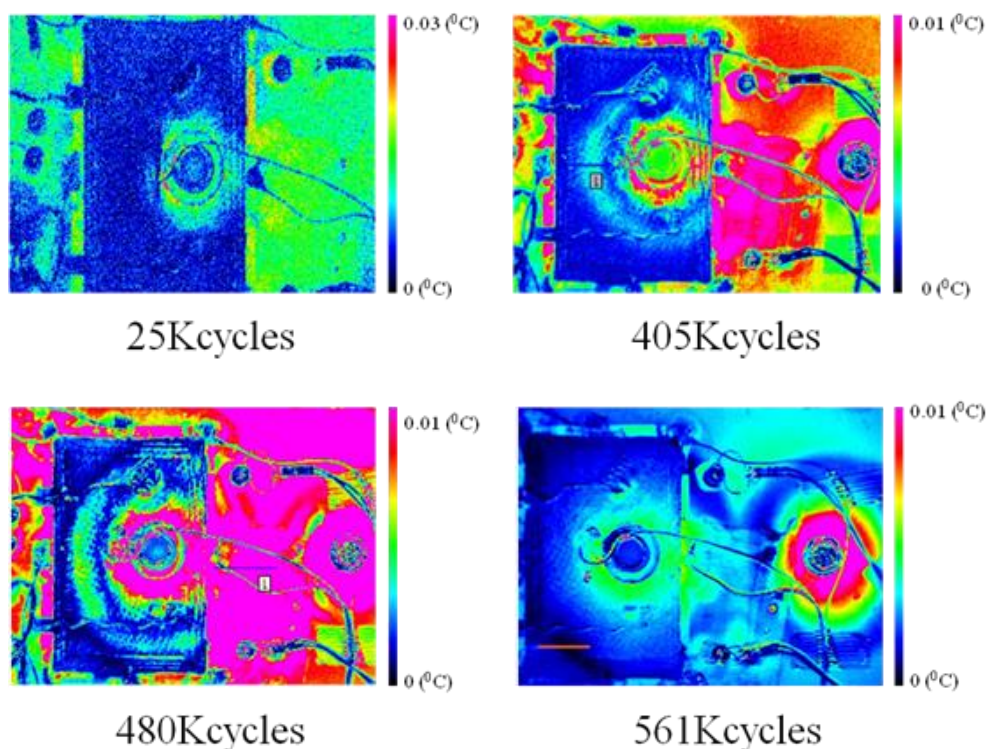
Figure 4. Amplitude images obtained from lock-in thermography at representative loading cycles.

The sequence of amplitude images in Figure 4, were observed with lock-in thermography during representative loading cycles. Amplitude images represent the recorded temperature difference on the structure. The deterioration of the patch is reflected by the color change on the particular images.

In the case of real-time damage assessment, IrT proved a powerful tool for damage initiation and propagation monitoring. The application of load was visualised as different colour contours on the surface of the patch. Mechanical loading generated stresses internally which led to the detachment of the patch from the Al substrate. Changes in colour mirrored the differentiation of the stress gradient along the repaired area. Generated stresses were the result of thermomechanical coupling. Thermographic images reflected the debonding process of the patch from the substrate. Debonding

initiated mainly from the loci of the bolted joint where apparently the mechanical stresses were maximum. Stress concentrations moved along the repaired area as the patch detached from the substrate. The artificial crack was initially visible, however, after prolonged testing, the loss of patch /substrate interface covered the thermal trace of the crack. This effect was a secondary proof that IrT was capable of capturing critical damage in real time, which in this study was manifested as patch debonding.
